Manhole Inspection Summary

Manhole # S21CC_030MH

Insp Date: **9/7/07 6:31 AM**

Location Address: **1041 MOUNT ST**

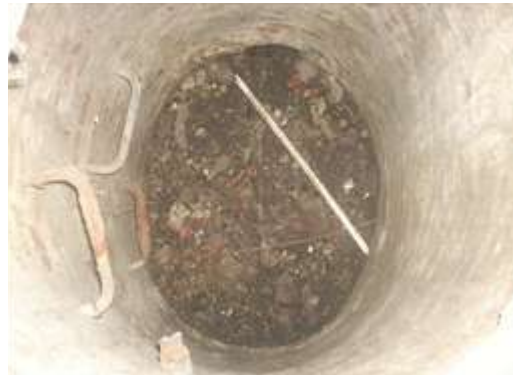
Top View

CHANNEL DEBRIS

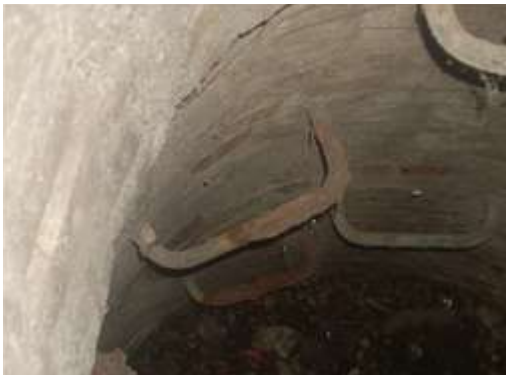
Defect 2

Count: **4** Missing: **0** ☒ **Corroded**

CORRODED STEPS

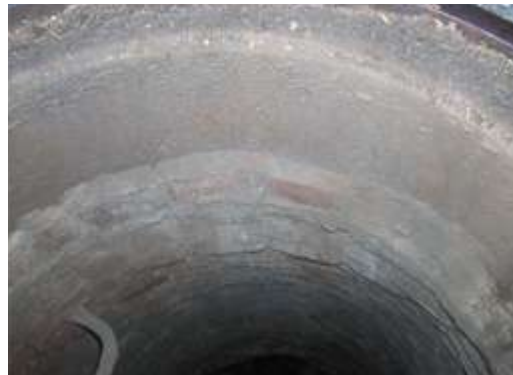
Defect 1

Offset: **1** (in.)

FRAME OFFSET

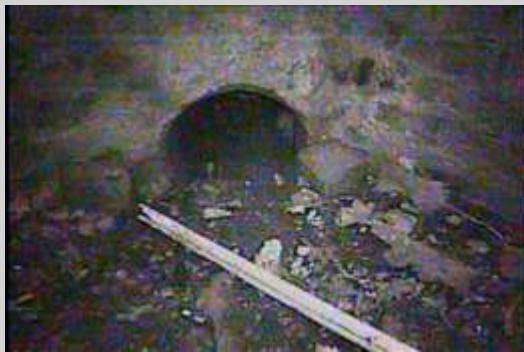
12 O'Clock Outflow

8 in. Circular Gravity Sewer
Pipe Out @ 12 O'Clock

Pipe Height: **7.2** (in.) Rod and Bar (Angled)

Pipe Material: **Clay** ☐ Pipe Lined

Infiltration: **None** Pipe Seal Cond: **Sound**
